Manhole Inspection Summary

Manhole # S61U__003MH

Location Address: **1719 Poncabird Pass**

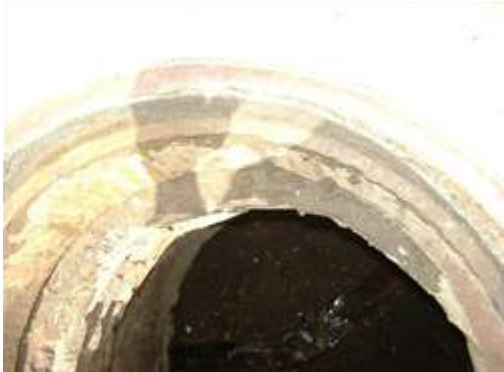
Defect 1

Frame Offset: **2** (in.) Condition: ☒ Sound ☐ Cracked ☐ Leaks

Offset

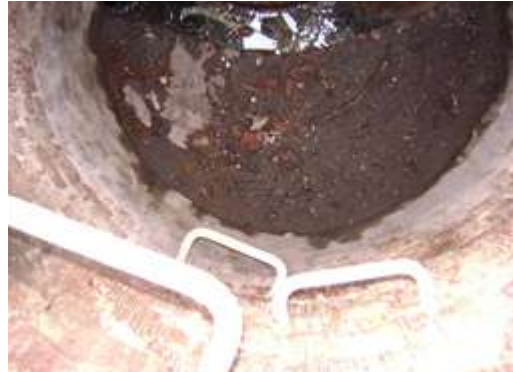
Defect 2

Condition: ☐ Sound ☐ Cracked ☐ Root Intrusion ☐ Deteriorated ☐ Leaks ☒ **Debris**

Debris On Bench

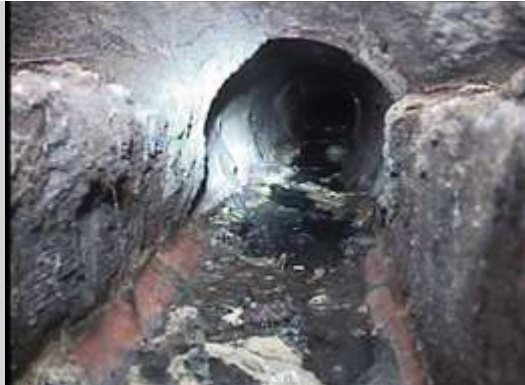
12 O'Clock Outflow

8 in. Circular Gravity Sewer
Pipe Out @ 12 O'Clock

Pipe Height: **8.4** (in.) Rod and Bar (Angled)
Pipe Material: **Clay** ☐ Pipe Lined
Invert Depth: **6.50** (ft.) Flow Characteristics: **Slow**
Deposits: ☐ None ☐ Mud ☐ Sludge ☒ **Debris** ☐ Grease
Silt Depth: **0.5** (in.) Deposits Extent: **Light**
Infiltration: **None** Pipe Seal Cond: **Sound**

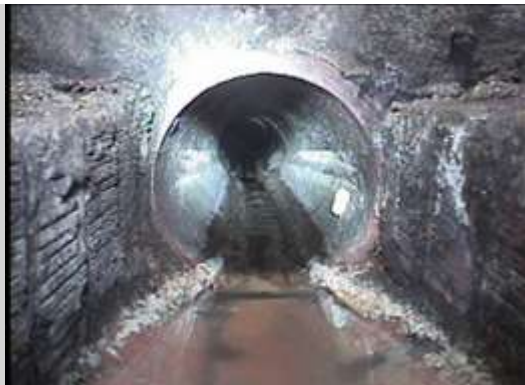
6 O'Clock Inflow

6 in. Circular Gravity Sewer
Pipe In @ 6 O'Clock

Pipe Height: **6** (in.) Rod and Bar (Angled)
Pipe Material: **Clay** ☐ Pipe Lined
Invert Depth: **6.42** (ft.) Flow Characteristics: **Slow**
Deposits: ☒ **None** ☐ Mud ☐ Sludge ☐ Debris ☐ Grease
Silt Depth: (in.) Deposits Extent:
Infiltration: **None** Pipe Seal Cond: **Sound**
